Watts Towers of Simon Rodia State Historic Park

Conservation Program
Department of Cultural Affairs
City of Los Angeles

Watts Towers Restoration Handbooks

Prepared by Jeffrey Herr, 15 May 2009
Photography by Zuleyma Aguirre
and Clinton Peterson
Baseline photograph by Marvin Rand

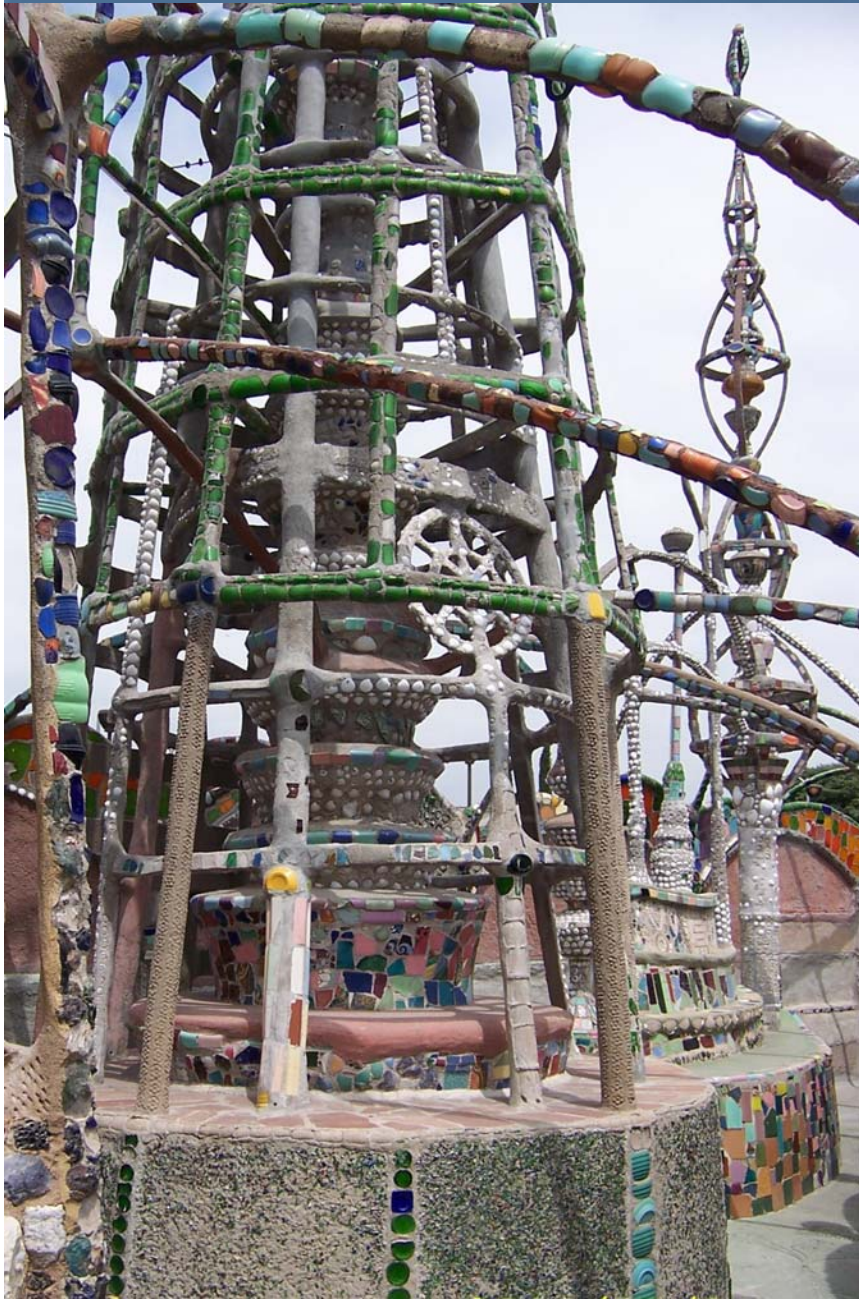
Method of Construction

Metal armature made of short pieces of steel that overlap are held together with steel or copper wire (Rodia used no welds).

Mortars of varying composition and consistency cover the framework.

Decorative elements including tile, crockery, glass and sea shells are embedded in the soft mortar.

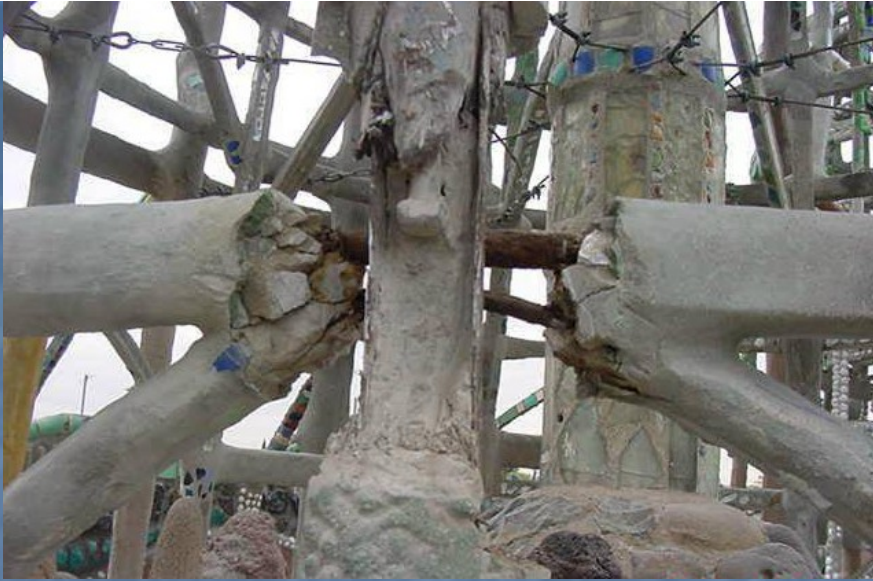
Structural Conservation Procedure

Photograph crack or compromised area

Open existing crack to assess condition of steel armature and photograph

Clean the exposed rusted steel where structural stability is not compromised

Remove compromised steel and replace with new material

Wrap steel with wire mesh

Cover with mortar and reattach decorative materials if applicable

Photograph finished repair

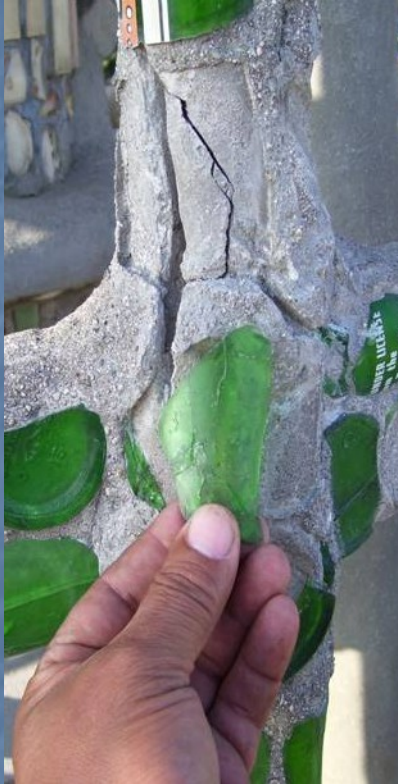
Description of a Typical Crack Repair

Photograph crack

Protect surrounding surface with polyethylene plastic

Clean crack with tools, brushes, water or air pressure

Degrease concrete with acetone

Inject epoxy into crack leaving a shallow void

Fill shallow void with custom concrete mix

Remove excess fill material

Either reattach original ornament or -
apply color and/or carve designs into concrete to
replicate original surface where appropriate

Photograph and enter repair information into database

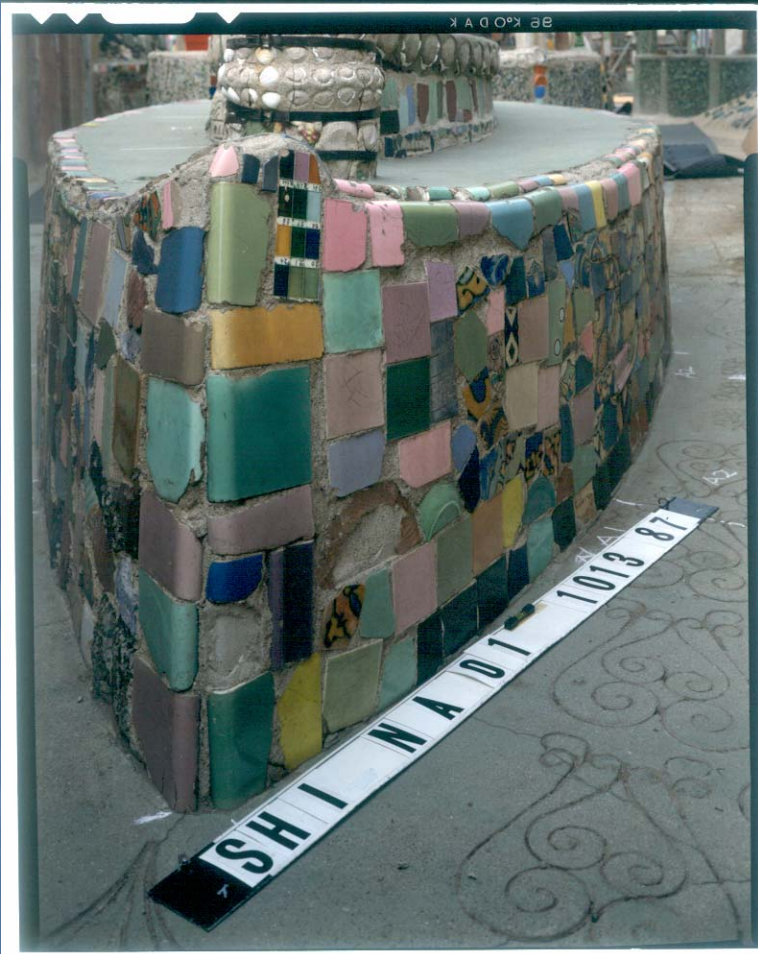
Ship of Marco Polo, North view, A level,
Photograph 1, 10.13.87

Photograph, Marvin Rand

Begun in 1986 and completed in 1992

Comprised of approximately 5000 images

Each keyed to a detailed grid and represents a four foot square area

The foundation for all conservation work

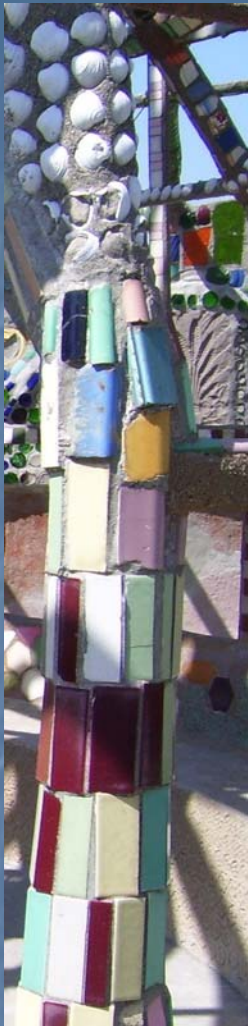
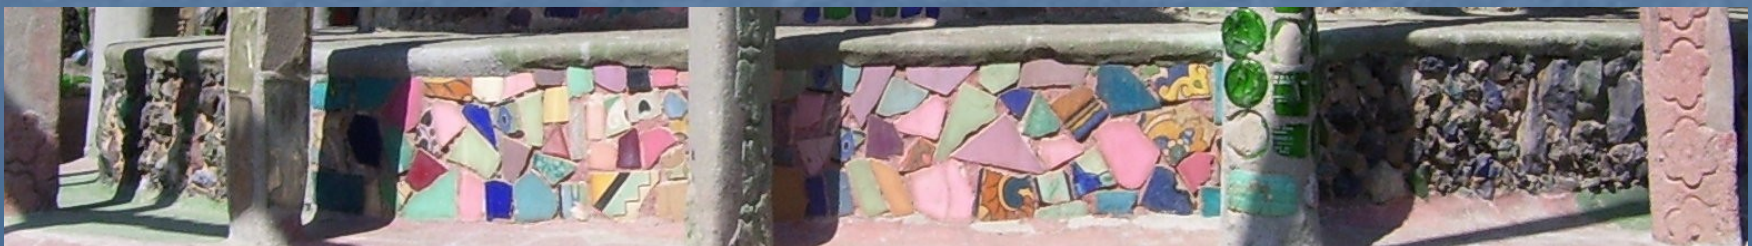
WATTS TOWERS OF SIMON RODIA STATE HISTORIC PARK CITY OF LOS ANGELES DEPARTMENT OF CULTURAL AFFAIRS CONSERVATION WORKSHEET			
			1577 DR CA FEMA
BY PROJECT CONSERVATOR OR ENGINEER			
Assigned by	Z AGUIRRE	2/24/2008	Assigned to PETERSON 11/14/2008
	Name	Date	Name Date
TASK (CIRCLE ONE)			
INSPECTION	EMERGENCY STABILIZATION	<input checked="" type="checkbox"/> CONSERVATION	STORAGE METHOD DEVELOPMENT
BASELINE LOCATION CTO_SSW_K_O_20081114_R87_DIG_IMG100_3818			
BY DATA ENTRY OPERATOR Data Entry by: C. Peterson 4/7/2009			
Damage Location (Overlay Grid on Baseline Location) Name Date			
BY PERSON PERFORMING ASSIGNMENT			
BASELINE LOCATION CTO_SSW_K_O_20081114_R87_DIG_IMG100_3818 11/14/2008			
Name Date			
DAMAGE LOCATION: PARTS OF SCULPTURE (COPY ONSITE) CENTER TOWER		REPAIRS MATERIALS AND TECHNIQUES DESCRIPTION	
Members Numbers /or Name EXT.COL # 3		MORTAR CUSTOM MORTAR MIX	
Circle those applicable		LAYERED MORTAR 2 COATS

I AM LOOKING AT: HORIZONTAL UP DOWN		METAL REBAR	
INSIDE OUTSIDE TOP BOTTOM		METAL MESH	
OF THE MEMBER		WIRE	
Elevation in feet from the ground 40' 00"		ADHESIVE & CAULK SIKADUR 35, 31	
EXISTING DAMAGED MATERIALS:		DECORATIVE ELEMENTS 2:1 Ratio Mixed	
Circle those applicable		GLASS	
MORTAR SINGLE REBAR MULTILAYER MESH		SEASHELL	
METAL WIRE		GLAZED TILES	
ADHESIVE & CAULKS TYPE		POTTERY	
ORNAMENTS & DECORATIONS		METALWARE	
POTTERY ORANGE SEASHELL GLASS GLAZED TILES		ROCKS	
METAL WORK ROCKS STATE REPAIRS INCISIONS & FORMS		INCISIONS/FORMS	
OTHER		STORAGE	
CRACK IN CONCRETE: VERTICAL 1		DESCRIPTION & SIZE OF PIECE	
		ID.# DATE	
		LOCATION OF STORAGE	
11/14/2008 Dig. Img. # 100_3803

11/14/2008 Dig. Img. #100_3818

Before Treatment		Dig Img100_3818_After Treatment	
JOINT			
ENTRIES	R87	OPERATION 4	2005 STORM DAMAGE
TECHNIQUE 1	USED SMALL CONSERVATION TOOLS TO CAREFULLY REMOVE LOOSE MORTAR		
TECHNIQUE 2	CRACK IN CONCRETE: SLIGHTLY OPENED, CLEANED AND DEGREASED W/ ACETONE; EPOXY PATCHED

TECHNIQUE 3	FILLED THE LACUNE WITH CEMENT AND SILICA SAND 3:1 RATIO MIXED, CLEAN EXCESS
